# Manhole Inspection Summary

Manhole # S53K\_\_028MH

Insp Date: **9/14/09 11:26 AM**

**Location** Address: **behind 810 S.Highland Ave.**

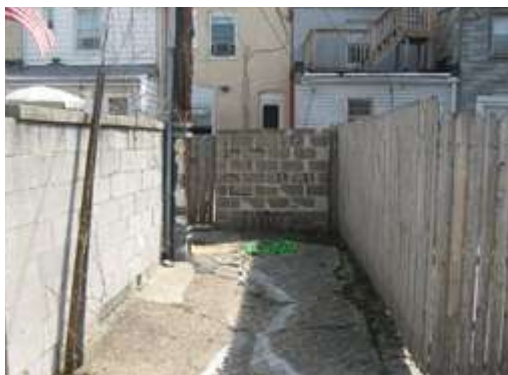
Location View

View facing east

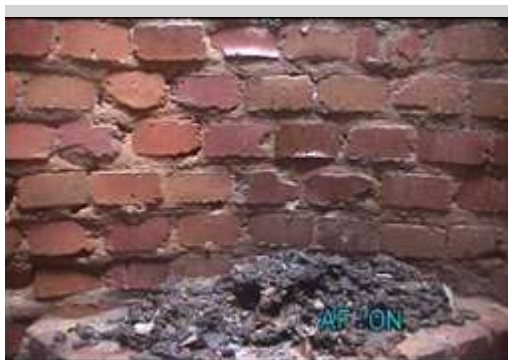
Miscellaneous

debris on the bench

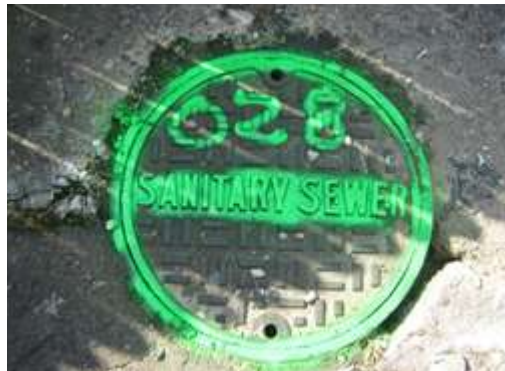
Miscellaneous

MH Lid

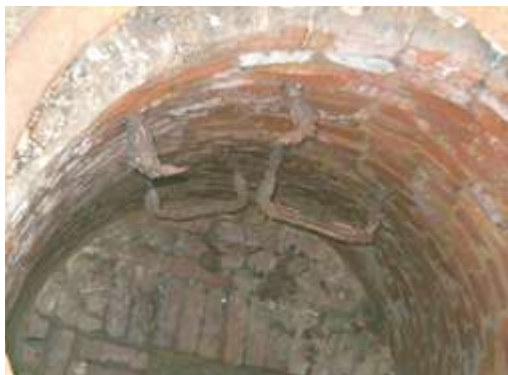
Defect 3

**Steps** Count: **3** Missing: **1** ☒ **Corroded**

missing/corroded rungs

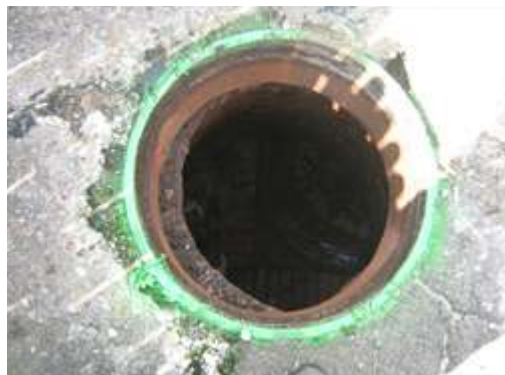
Defect 2

**Frame** Offset: **3** (in.) Condition: ☒ Sound ☐ Cracked ☐ Leaks

frame offset

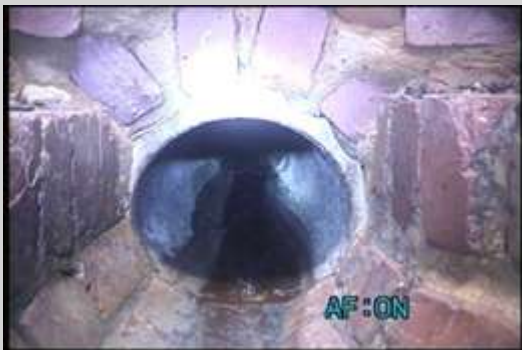
12 O'Clock Outflow

8 in. Circular Gravity Sewer  
Pipe Out @ 12 O'Clock

Pipe Height: **8.4** (in.) Rod and Bar (Angled)  
Pipe Material: **Clay** ☐ Pipe Lined  
Invert Depth: **7.70** (ft.) Flow Characteristics: **Slow**  
Deposits: ☒ None ☐ Mud ☐ Sludge ☐ Debris ☐ Grease  
Silt Depth: **0** (in.) Deposits Extent:  
Infiltration: **None** Pipe Seal Cond: **Sound**

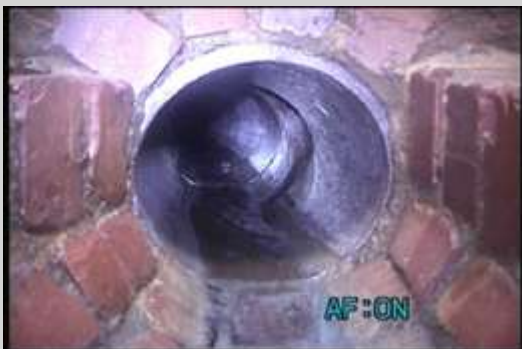
3 O'Clock Inflow

8 in. Circular Gravity Sewer  
Pipe In @ 3 O'Clock

Pipe Height: **8.4** (in.) Rod and Bar (Angled)  
Pipe Material: **Clay** ☐ Pipe Lined  
Invert Depth: **7.30** (ft.) Flow Characteristics: **Slow**  
Deposits: ☒ None ☐ Mud ☐ Sludge ☐ Debris ☐ Grease  
Silt Depth: **0** (in.) Deposits Extent:  
Infiltration: **None** Pipe Seal Cond: **Sound**
